The Cutty Sark,
The Trials and Tribulations of a Restoration Project

Prepared by
Wyn Davies
Senior Consultant,
Frazer-Nash Consultancy Ltd.,
Bristol, UK.

September 2004

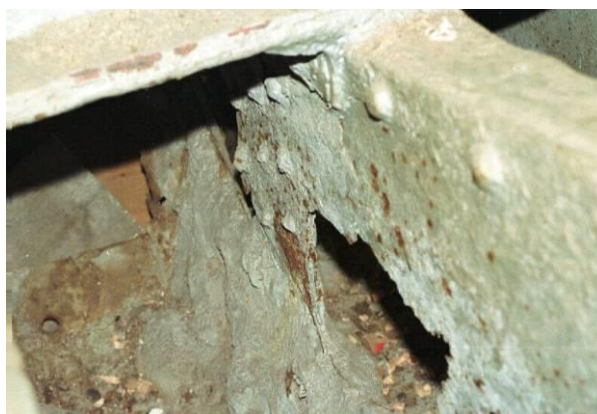
Cutty sark11.jpg

They would not, however, be so familiar with this view of the floors in the hold. These are in fact below the false deck added to aid access to the hold in 1955, so admittedly not readily visible to the visitors.

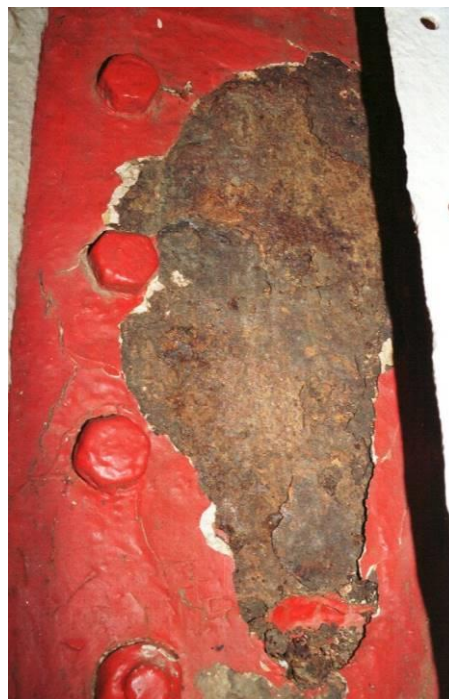
Cutty Sark7.jpg

This is one example of the corrosion damage, rust flaking off a stringer plate behind the figureheads. The whole of the wrought iron structure is suffering from corrosion and decay to a greater or lesser extent. As is only to be expected this corrosion is causing pressure between iron surfaces, which could lead joints to fail, bolts to snap and the overall structure to become unsafe.

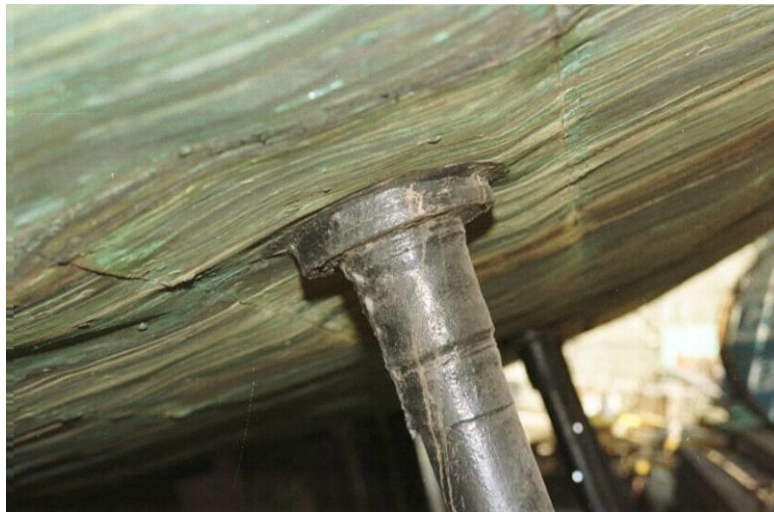
Cutty Sark9.jpg

The planks are held in place by Muntz metal bolts, with the wrought iron giving a perfect combination of metals for electrolytic corrosion when wet. As a result of this electrolytic action, timber adjacent to the iron also shows signs of electrolytic decay, softening to the point where a knife point can be pushed in easily.

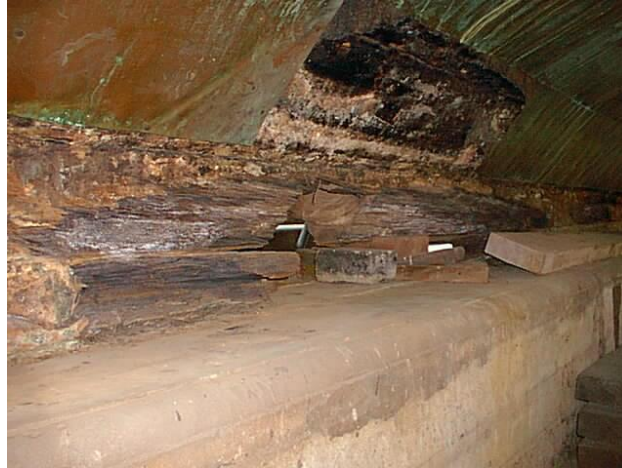
Cutty Sark20.jpg

The result of this leak was bilges filling up with rain (and, unfortunately, wash down water) which was trapped in by the sheathing, the keel area was permanently water logged and the chlorides left in the structure from her years of service were reactivated with a vengeance.

A view of the keel on the concrete plinth showing the gaps in the sheathing.

Once Simon Waite, her then master, made the discovery in the early 90's, he removed the Muntz metal at the keel to allow the water to drain out and happily most of the keel and false keel dried out, although some replacement was necessary at the time and more is likely to be required now.

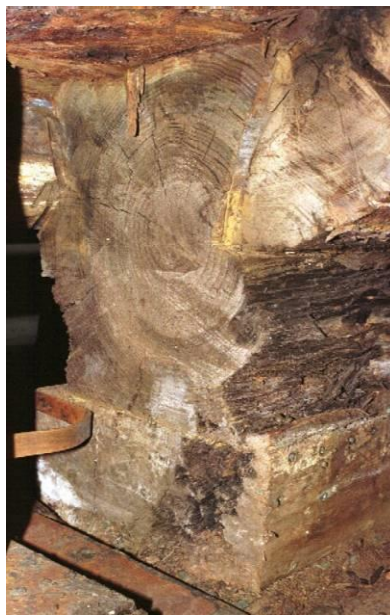
Cutty Sark8.jpg

This is the keel and false keel after drying out.

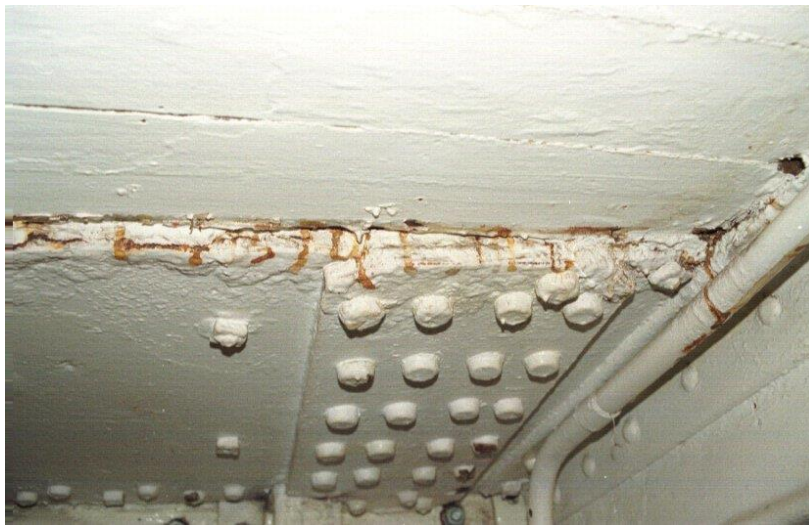
Cutty Sark21.jpg

The source of all these problems can in almost all cases be directly attributed to rain leaking through the main deck. The main deck is believed to mainly consist of a triple sandwich, designed to represent the original deck when viewed from either above or below. It is believed that it even includes some roofing felt. Whilst it is difficult to find the source of a leak in a "normal" sandwich deck, it is virtually impossible with Cutty Sark's arrangement.

Typical corrosion damage beneath the main deck.

The problem of the “leaking roof” is relatively straightforward to solve and it will be replaced with one identical to that originally designed for the ship. Work is now progressing to find a source of suitable teak.

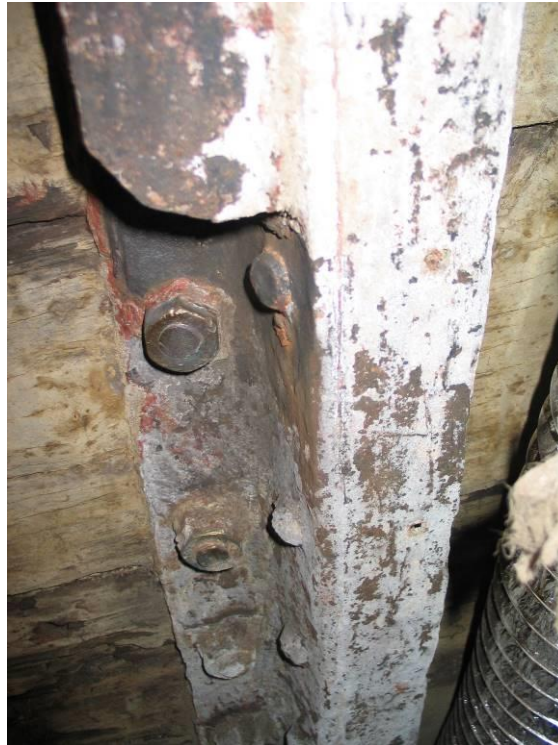
Cutty Sark26.jpg

The next figure illustrates the relative cleanliness of the wrought iron structure after the experiment, with but a few discoloured patches remaining awaiting the high pressure wash down.

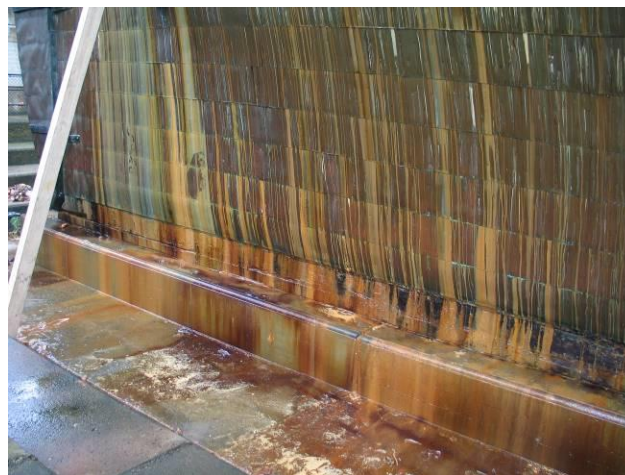
Cutty Sark27.jpg

One of the side effects is shown in this figure. Copper salts, iron oxide compounds and the pale sand used to try and stop up the leaks combined to produce a colourful finish to the sheathing wherever the leaks came out. It should be noted, however, that water rich in iron, which reduces pH, may adversely affect metals it comes into contact with.

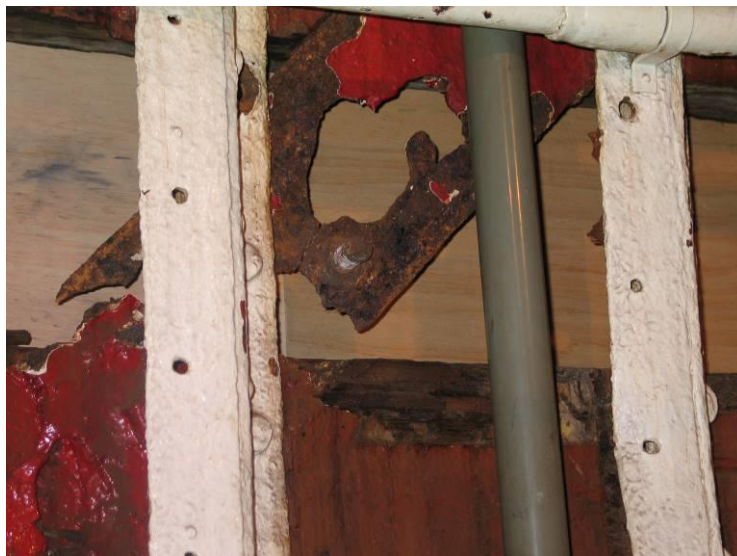
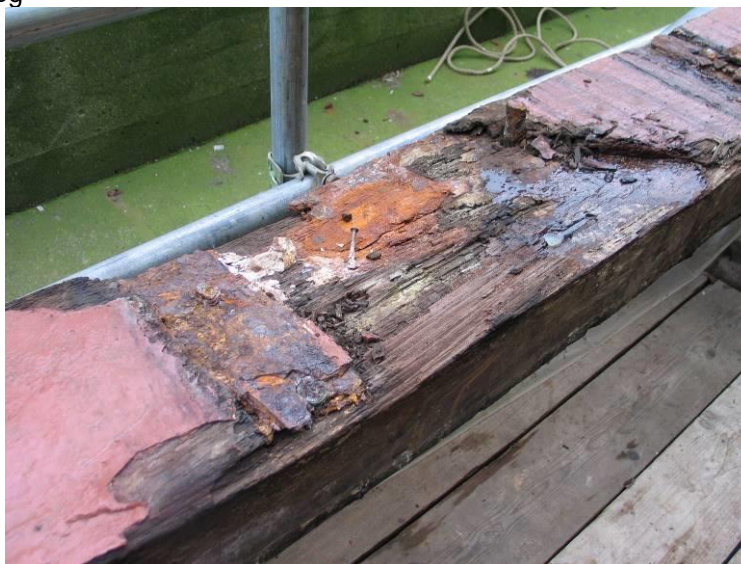
To check on the cost of this process, and to gain some more information on the state of the ship's timbers, Tommi Nielsen of Gloucester was contracted to remove one plank. The elm plank selected was one that crossed a large number of wrought iron members, thus it was probably one of the weakest. Tommi and his team did a splendid job, and the ship now has a hole in the port side and the team has possession of one slightly ratty plank.

The plank was basically intact and seem to have retained a degree of strength beyond expected for its species. Possibly due to being pickled by salt.

The caulking had dried to the point where it served only as a draft excluder, revealing that the planks were still separate and weren't carrying any load, a

possibility that had concerned the author ever since first seeing the corroded wrought iron.

Only something like 12% of the bolts were intact and serving their intended function. They would have to be replaced throughout, but to keep English Heritage satisfied it is proposed to melt down the old bolts and re-use the metal.
